**PRELIMINARY GEOLOGY AND
GEOTECHNICAL EVALUATION
Proposed City Heights Development,
Cle Elum, Washington**

Prepared for: Northland Resources, LLC

Project No. 090081-001 • October 1, 2009

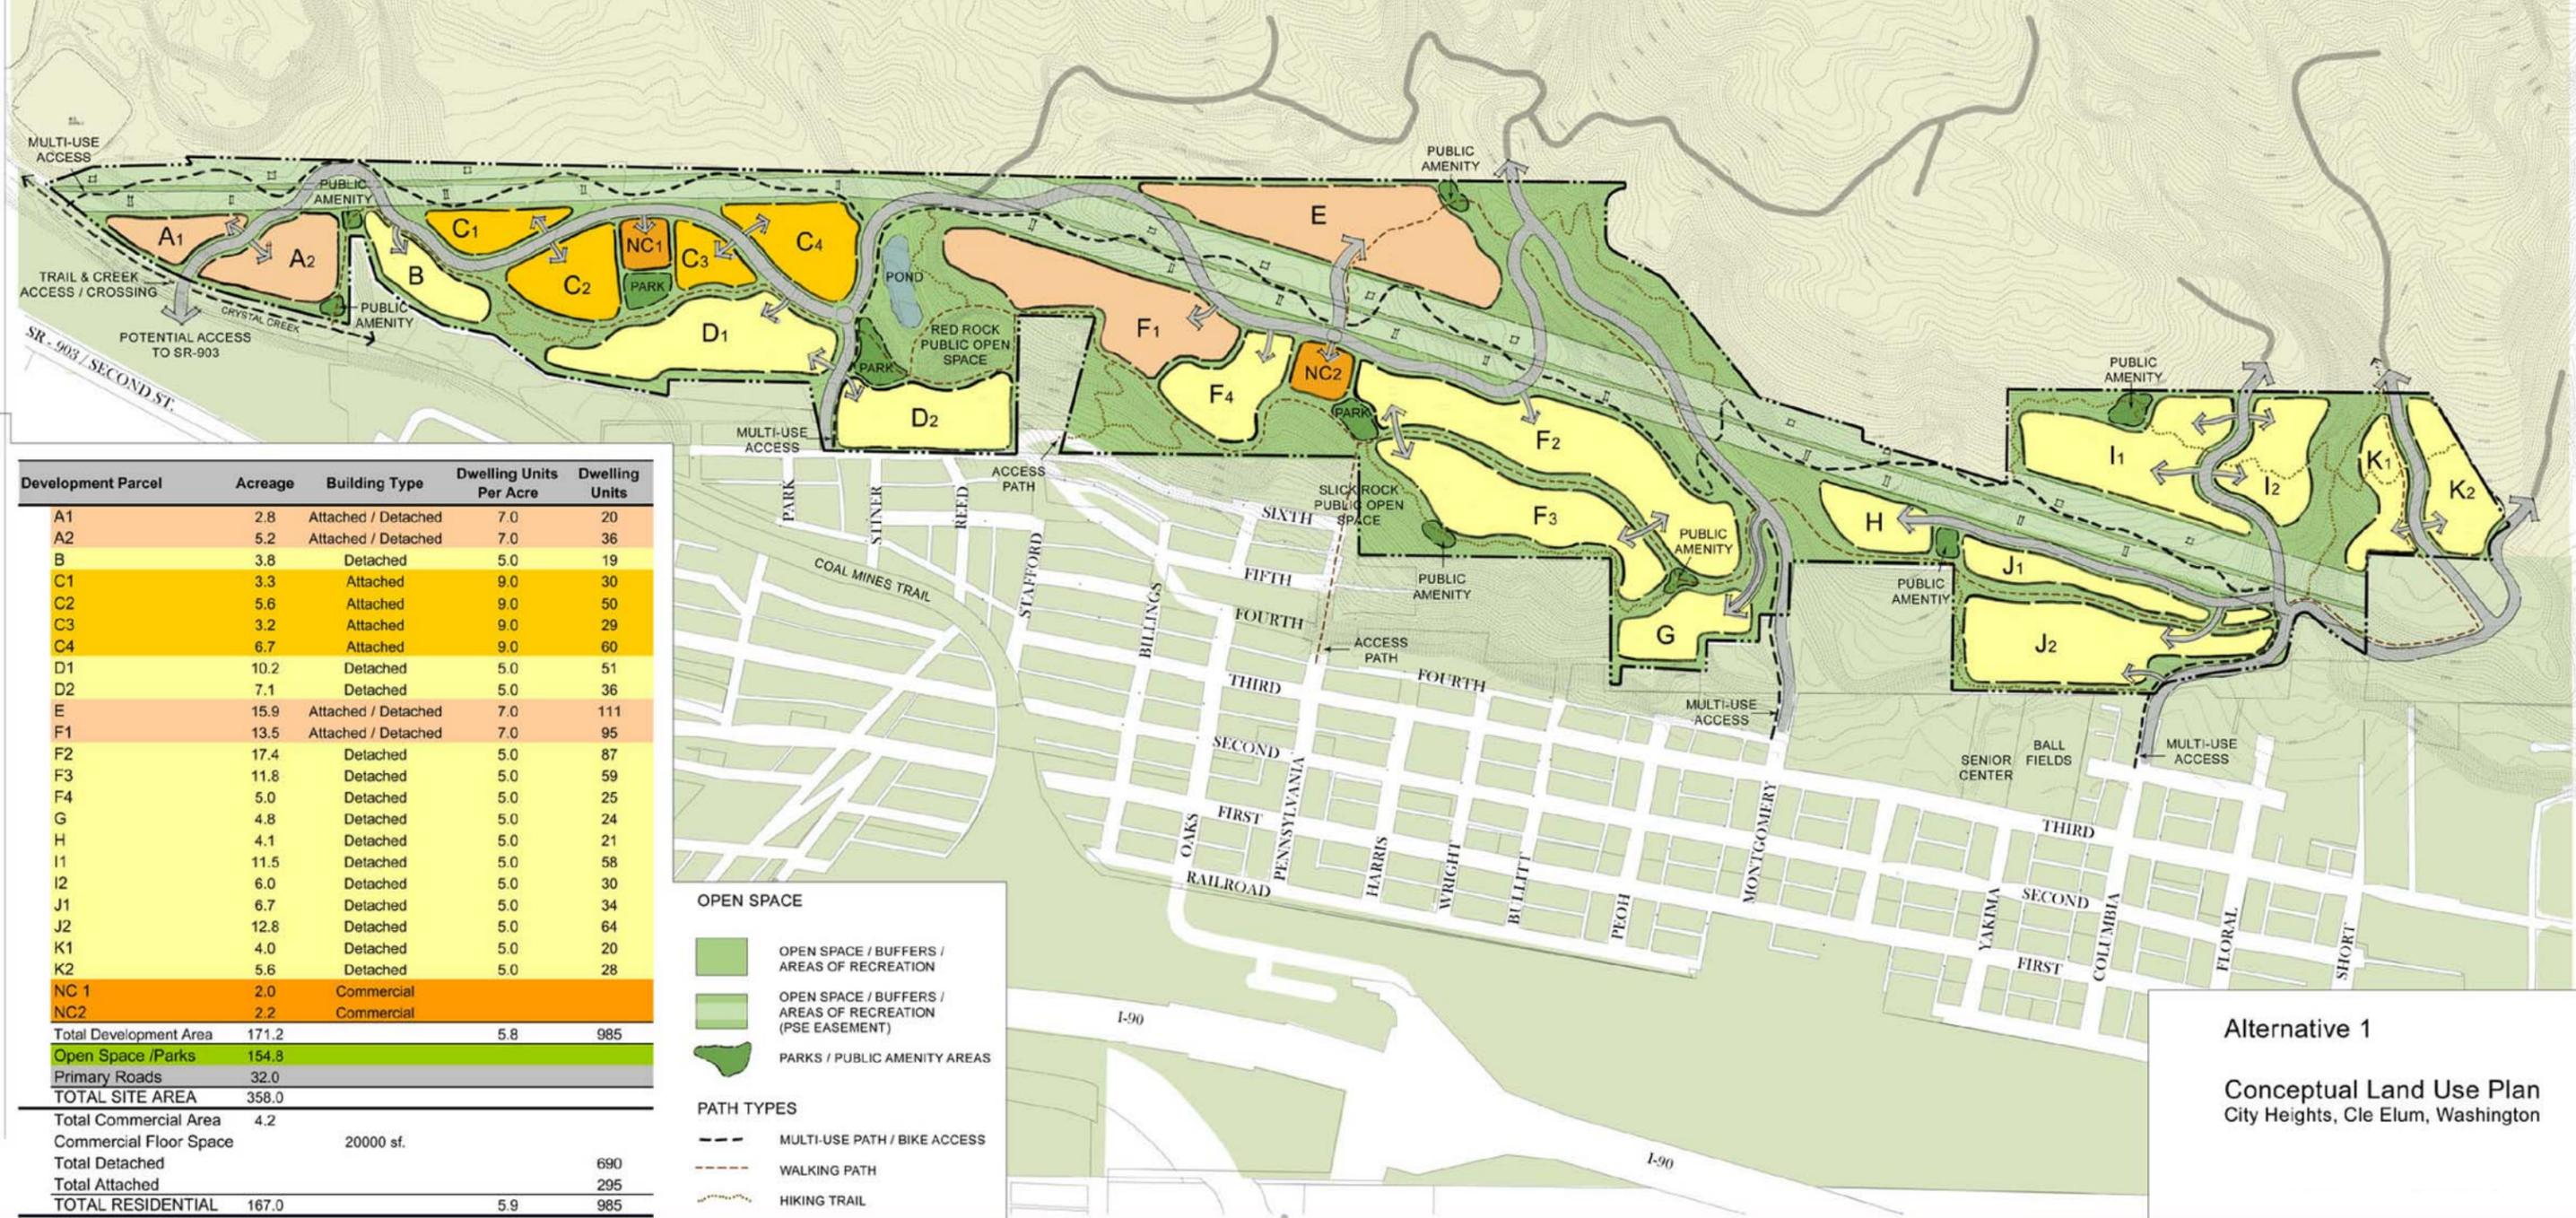
Conceptual Land Use Plan
 Preliminary Geology and Geotechnical Evaluation Report
 City Heights
 Cle Elum, WA

Alternative 1
 Conceptual Land Use Plan
 City Heights, Cle Elum, Washington

range from 1,500 feet to 2,400 feet. Bedrock consists of relatively weak, interbedded sandstone, siltstone, and mudstone with occasional coal seams. Bedrock is observed at the surface in an outcrop at the “Slick Rock” area west of proposed Development Area F3, in road cuts along Deer Creek Road, and in the northern portion of Development Area E (see Figure 2).
