Sewall Wetland Consulting, Inc.

March 11, 2021

RE: City Heights Phase I Summit View Road – *Revised* Critical Areas
Report & Improvement Impacts Analysis
SWC Job #A9-121

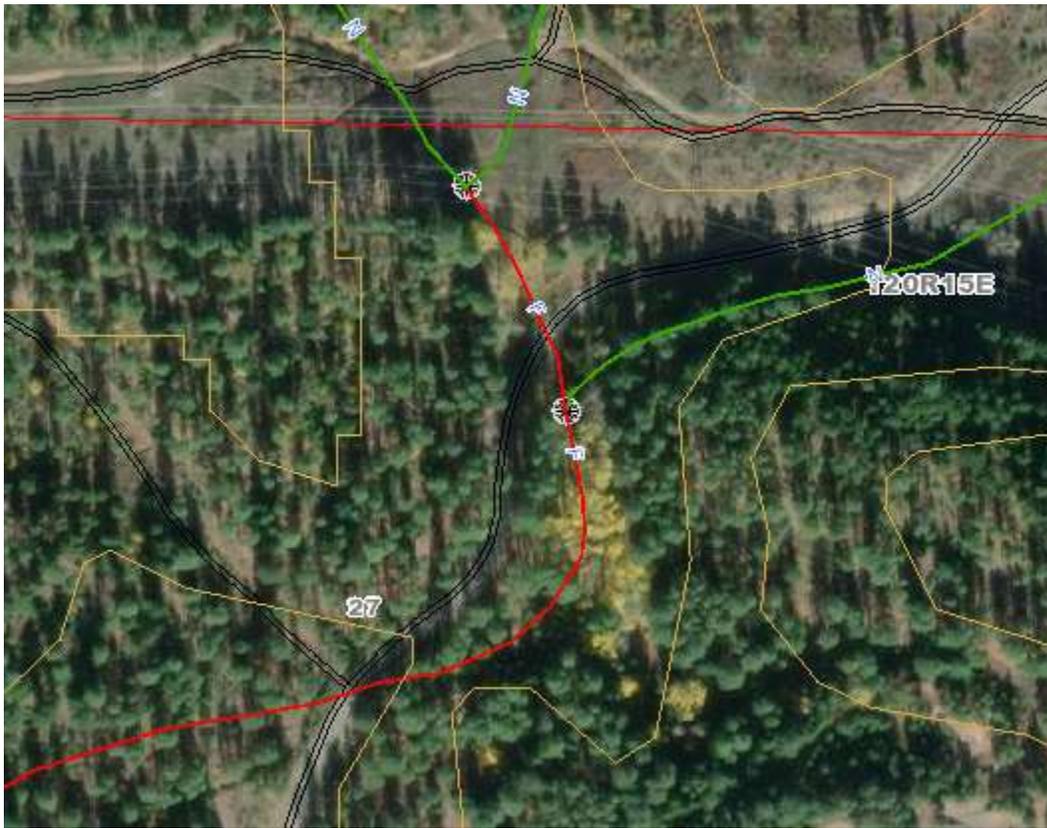
The WADNR Fpars Stream Typing website depicts a Type F stream passing through the site at both crossings. Note, many of these streams in this inventory are interpolated from aerial photographs and topographical mapping with no field verification.

Above: WADNR Fpars Stream mapping of the site.

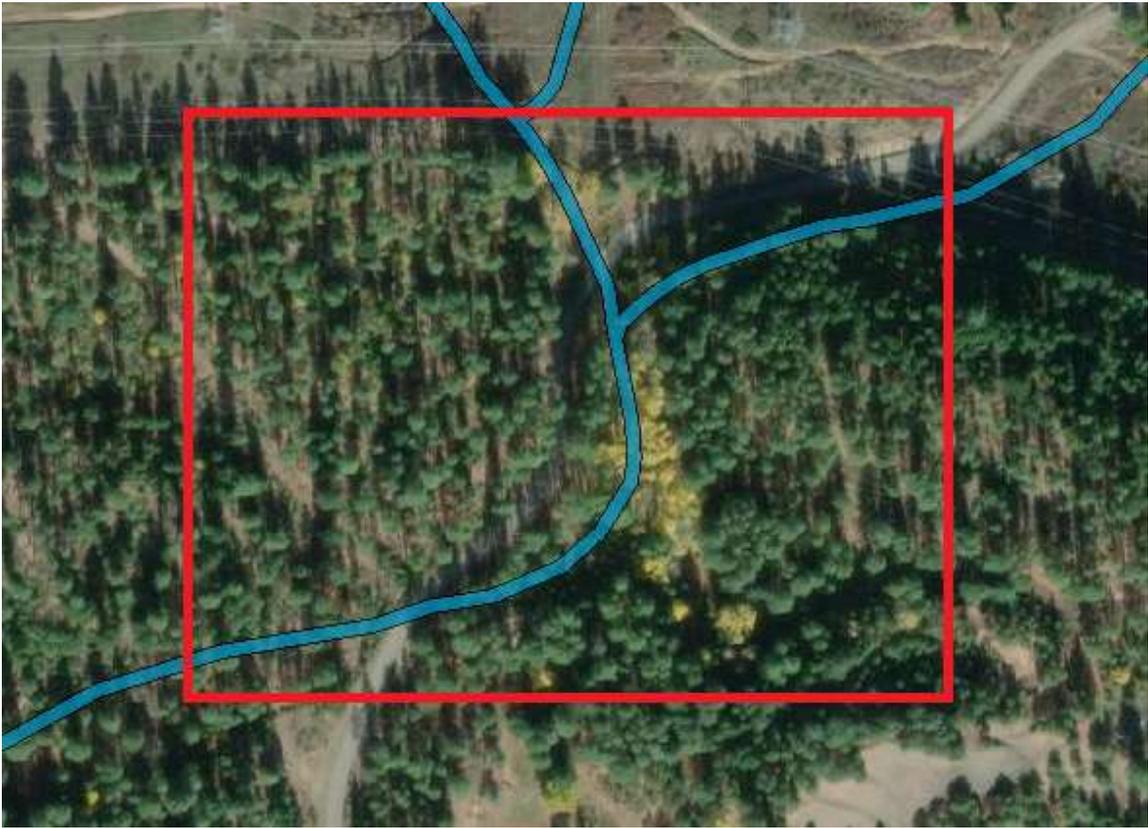
The NWI map depicts streams as shown on the WADNR Fpars mapping and is a carryover from that inventory. As detail in the online data, this mapping was done through “photointerpretation” using a 1:50,000 scale color infrared photograph taken in 1983. No field verification was done for this inventory area.

Above: NWI map of the area of the site

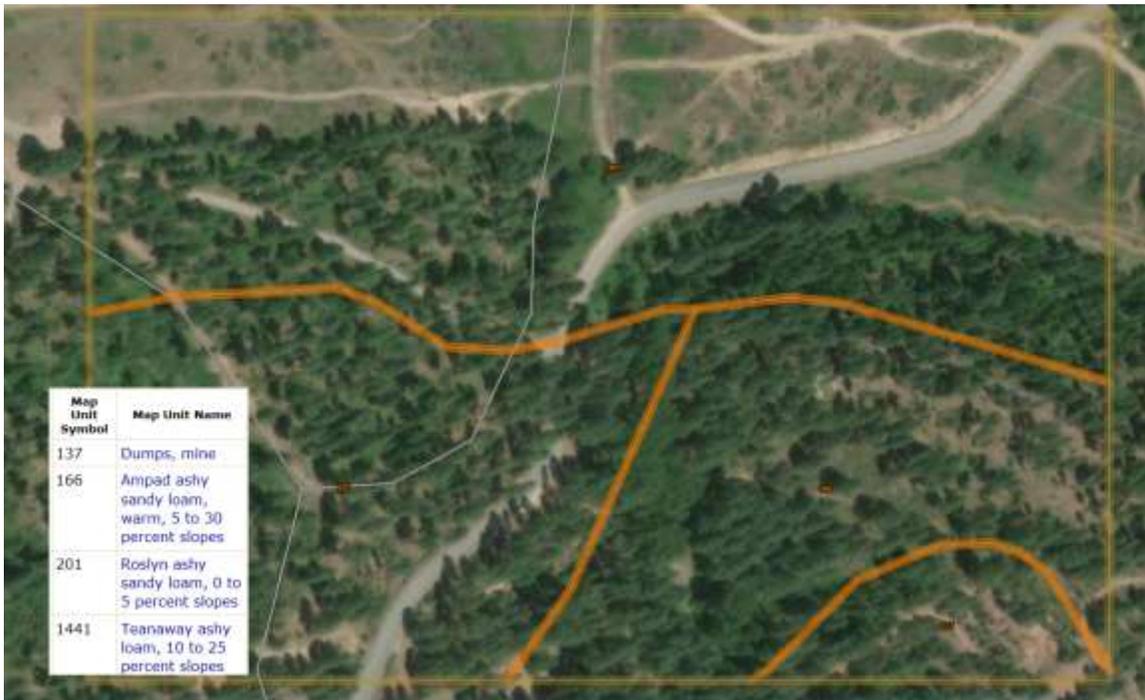
According to the NRCS Soil Mapper website, the areas of the crossings area mapped as Teanaway ashy loam, 10%-25% slopes, and Roslyn ashy loam, 0%-5% slopes. Neither of these soils types are considered a wetland soil according to the publication Hydric Soils of the United States (USDA NTCHS Pub No.1491, 1991).

Above: NRCS soil map of the site.
